SHREMSHOCK ARCHITECTS, INC.

RE: Proposed Mount Vernon Performing Arts Center at the Armory
Mount Vernon, OH. 43050

Shremshock Companies has prepared this preliminary study on behalf of the Performing Arts Center to assess the feasibility of adapting the existing Armory Building (located at the corner of Mansfield Ave. and Curtis Street in Mount Vernon, Ohio) for use as a performing arts center.

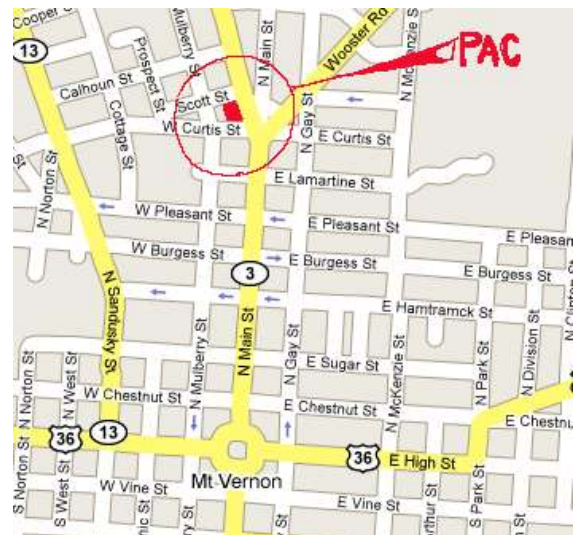
The site is easily accessible by pedestrian and vehicular traffic. Pedestrian access is available via sidewalk along the front Mansfield Ave., Curtis Street; no sidewalk exists along Scott Street alley. Curtis Street provides curb-side parking; off-street parking is located in a paved lot accessed from Scott Street alley off the building's rear entrance. The parking lot is enclosed by a chain link fence. The site is essentially flat, but the terrain slopes the east. Stairs to both entrances, however, are barriers to accessibility.

Further study of the parking availability is recommended. The site is appropriate to support use as an arts center barring any restrictions discovered from this study and the

availability of adequate parking. Additional parking for events may be able to be negotiated with local businesses located directly to the east of the Armory site.
